BELZONA PROTECTS PIPELINE AND VALVES FROM CEMENT ABRASION

Cement producer, Slovakia

Pipes and valves used to transport cement dust.

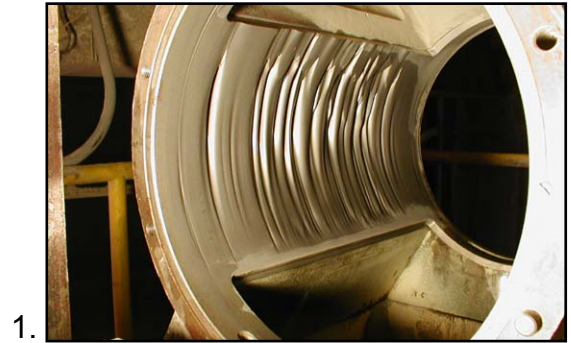
There was high abrasion caused by cement leading to local material loss of metal from valve body.

1. Badly eroded valve
2. Grit blasting the valves
3. Completed valve body
4. Re-assembled valve protected with Belzona® 1811
