BELZONA SEALS SKYLIGHTS OVER PRODUCTION HALL

Machinery plant, Slovakia

Skylights in the roof of production hall

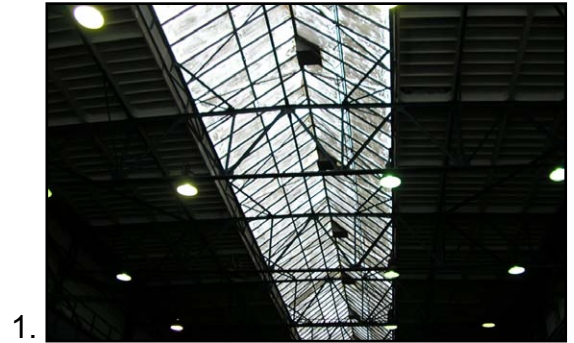
Corrosion of steel frame and rubber seal degradation on the skylights, caused by the effects of weather, was allowing rainwater to leak directly into the production hall creating safety issues and damage of interior machinery.

1. Skylights on the production hall
2. Corrosion of steel frame
3. Application in progress
4. The skylights in "as new" condition
