BELZONA REINFORCES EXCAVATOR BEARING SEATS

Open cast mine, Poland

Rotary turntable bearing of one of their bucket wheel excavators used in the open cast strip mine (brown coal)

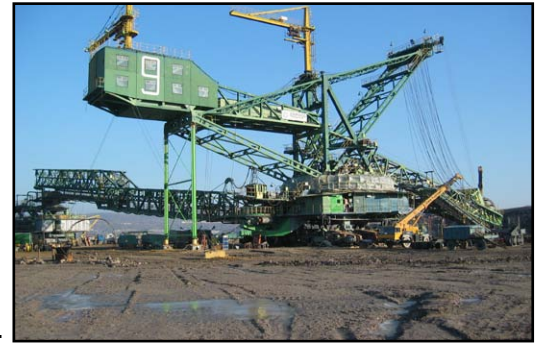
1. Excavator profile
2. Bonding the plates with Belzona® 1111
3. Preparation for injection
4. Injection of Belzona® 5811; In the diagram, Belzona® 1111 is shown in blue and Belzona® 5811 in beige.
