## SCRUBBER FILTER FRAMES REPAIRED PROTECTED WITH BELZONA

Phosphoric acid producer, Morocco

January 2012

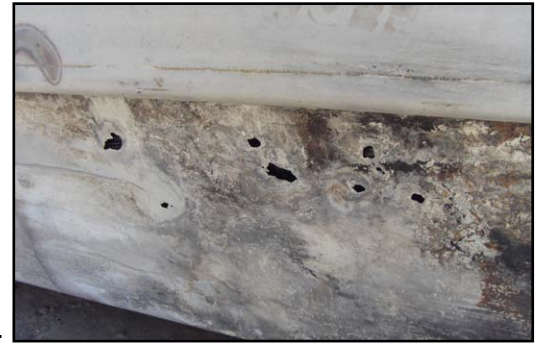
The environment contains up to 2,6 mg/Nm<sup>3</sup> phosphoric acid which leads to severe corrosion problems.

1. Scrubber filter frame before the application
2. Filter frame grit blasted
3. Application in progress
4. Application to one of the scrubber filter frames completed
