## BELZONA LEVELS LOADING QUAY

Animal feed manufacturer, Canada

Loading quay

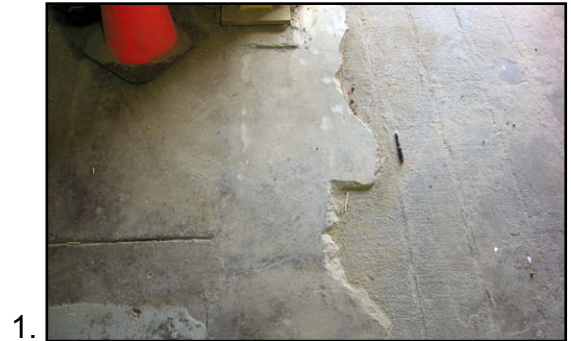
A less costly alternative repair had lasted only 6 months (picture 1). Belzona 4111 is still intact after 1 year in service, due to its excellent bond strength, impact resistance and compressive strength.

1. The failed previous alternative repair
2. Surface preparation
3. Completed application
4. Application after 1 year
