FRANCIS TURBINE SHAFT PROTECTED WITH BELZONA

Hydroelectric Power Station, France

Main shaft, 160 mm diameter, 1000 rpm.

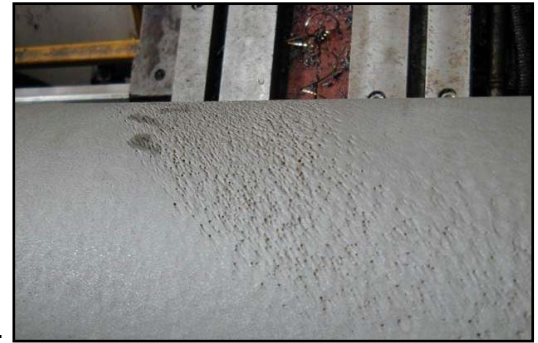
Shaft damaged by cavitation and erosion

1. Shaft damaged by cavitation/erosion
2. Belzona® 2141 after the application
3. Inspection of Belzona® 2141 protection of the turbine shaft after 9 months in service.

After blasting the surface, Belzona® 1341 was applied in one coat. Belzona® 2941 conditioner was used to tie in the Belzona® 2141 system.

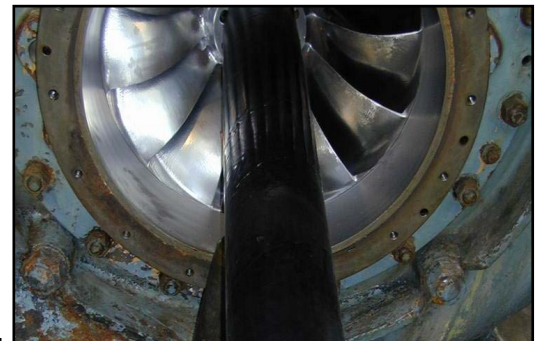
The application was carried out on the shaft in a lathe and the finish was obtained by using a rubber squeegee. Inspection of the Belzona® 2141 in 2007 and 2010 showed the system still in perfect condition.
