BELZONA SIMPLIFIES CONVEYOR BELT REPAIRS

Newspaper Distribution Centre, South East, UK

December 2010

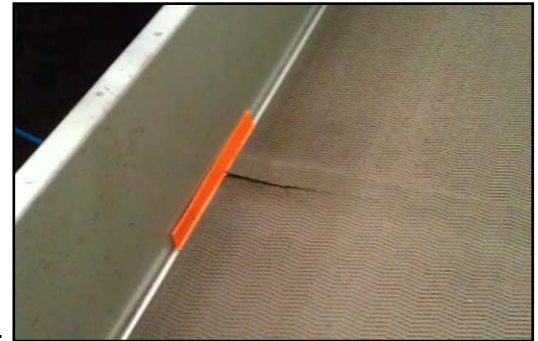
1. Roughing up the damaged surface
2. Applying the Belzona Elastomer Conditioner
3. Application of Belzona® 2311 to the masked area
4. Completed application with Belzona Reinforcement tape embedded in the repair and ready to go back in service

Application was carried out in accordance with Belzona Know-How System Leaflet SHM-1. The conveyor belt was stopped once the shift had finished and can be repaired before the next start-up.
