BELZONA REPAIRS WATER JET FLANGE AREA

Naval shipyard, Vaxholm, Sweden

Rolls Royce water jet propulsion unit on combat boat built 2002. Total time in water almost 6 years.

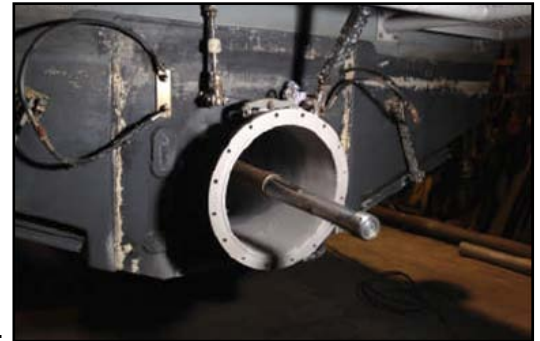
The water jet tunnel was suffering from cavitation and corrosion the flange holding the impeller housing in place. The most severe damages were found on the flange face and extended 20 cm inwards. Additionally the flange face was found to be distorted.

1. The damaged water jet unit
2. A close-up of the damage
3. Machining down the flange surface after rebuilding with Belzona® 1111
4. completed application after coating with Belzona® 1341
