## BELZONA REPAIRS DAMAGED FLOOR AT CIDER PLANT

Cider producer, Herefordshire, UK

Inspection hut floor in cider storage tank area

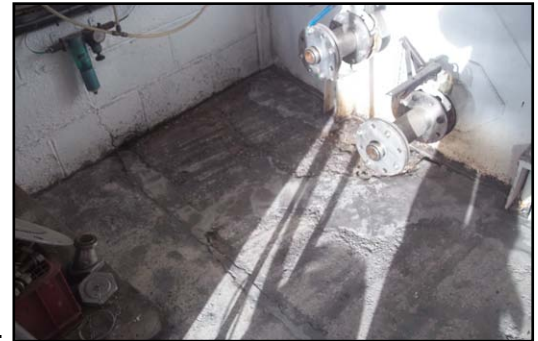
Due to spillage of cider concentrate the concrete floor had begun to break up and created health and safety issues with trips and slips.

1. Damaged floor
2. Application of Belzona® 4131 including conditioner to ensure maximum adhesion
3. Complete floor repaired with Belzona® 4131
4. Application of Belzona® 5231 completed
