## BELZONA MAKES WALKWAY SAFE

Cider producer, Herefordshire, UK

Walkway in production area of Cider Plant

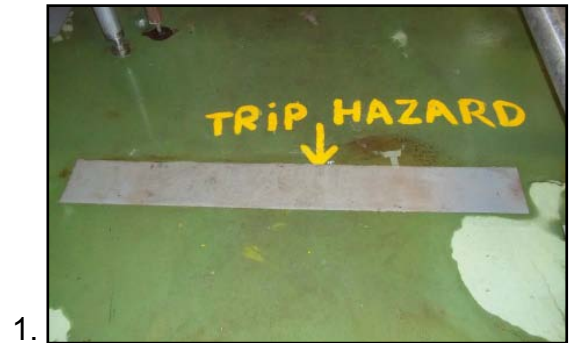
1. Trip hazard levelled with Belzona® 4131
2. Application of Belzona® 4411
3. Removal of masking tape
4. Completed application.

Application was carried out in accordance with Belzona Know-How System Leaflet FPA-8. Belzona® 4131 applied to level floor area before applying Belzona® 4411 grip system.

When routine maintenance was carried out they would step out of a small bund with wet feet. Belzona® 4131 ability to be feather edged allowed easy levelling of the walkway. The yellow Belzona® 4411 was chosen as both a positive grip system and as a visual aid.
