MAJOR BELZONA SAFETY REPAIRS IN BOTTLING HALL

Distillery, Glasgow, UK

November 2011

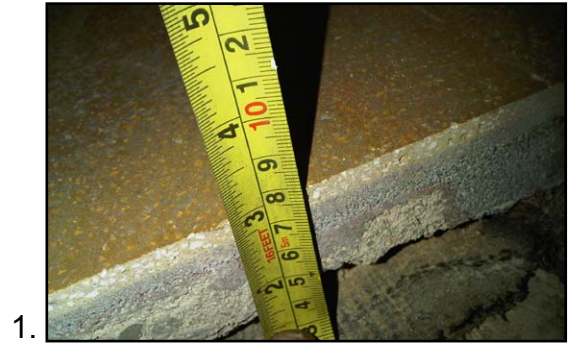
The areas were approximately 80mm deep and required filling and levelling. The three areas were a severe safety risk to the trucks operating in the plant leading to imbalance and disruption to production. The repairs had to be completed over a weekend shut-down.

1. Depth and problem of repairs required
2. Concrete slabs being bedded in prior to final Belzona® 4131 screed
3. Finished screed application
4. 2 coats of Belzona® 5231 with encapsulated aggregate applied for safety and grip
