BELZONA REPAIRS CORRODED GAS PIPE AT BOILER HOUSE

University, Manchester UK

Main gas feed pipe to boiler house at large University building.

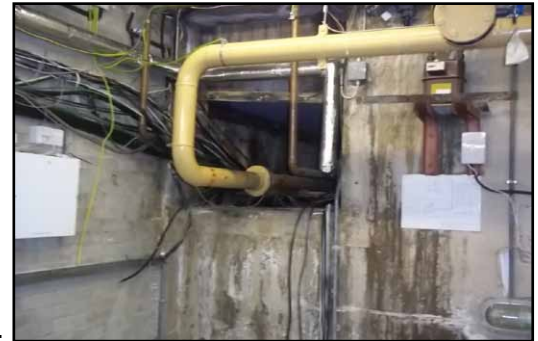
1. The entry point of the Gas pipe via a service tunnel making access and application difficult
2. Close up of corroded section of pipe
3. Completion of Belzona 1161 application
4. Completion of application including final coat of Belzona 5831

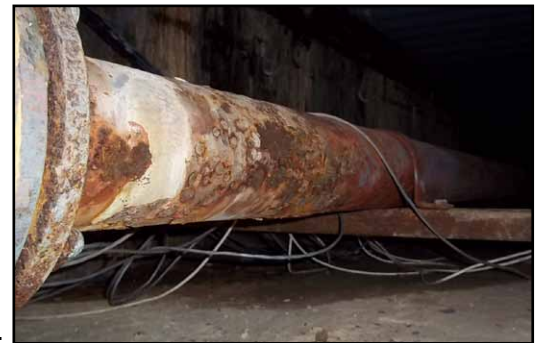
2.

Following asbestos removal several years ago, a section of a gas main pipe had been left exposed to water ingress from above and as a result had suffered corrosion and metal loss. The client required a solution that was quick, easy and safe to apply to a live gas pipe, that would replace the Metal loss and provide lasting protection from further corrosive attack.

The application was carried out in accordance with a modified version of Belzona Know-How System Leaflet VPF-11. Belzona 1161 was applied to rebuild and protect the badly corroded section of the pipe followed by a heavy coat of Belzona 5831 for added corrosion protection.
