## BELZONA REPAIRS DAMAGED CONCRETE IN PRIMARY SCHOOL PLAYGROUND

Derbyshire UK

December 2009

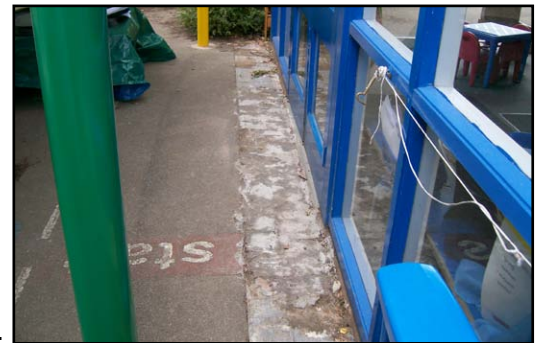
2.

Some loose and damaged tiles had been removed in the playground bordering a class room. This had left concrete exposed and the area looking unsightly and representing a potential slip/trip issue for young children.
