BELZONA SOLVES CORROSION LEAKS ON TRANSFORMER LV TURRET

Electricity Substation, South Coast, UK

Outage to Super Grid Transformer and inspection to all exterior HV & LV bushings sited to the Noise Enclosure roof area.

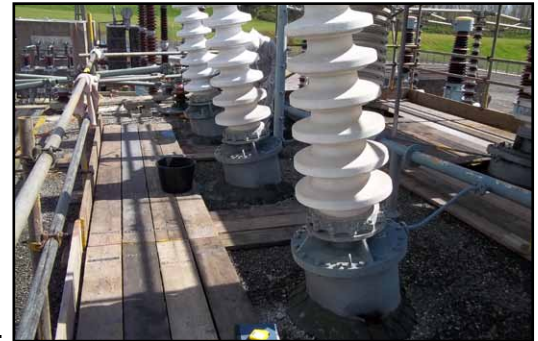
1. Location of three LV Turrets
2. Corrosion and live leak oil discharge
3. Plate bonding
4. Work completed on one of the Turrets

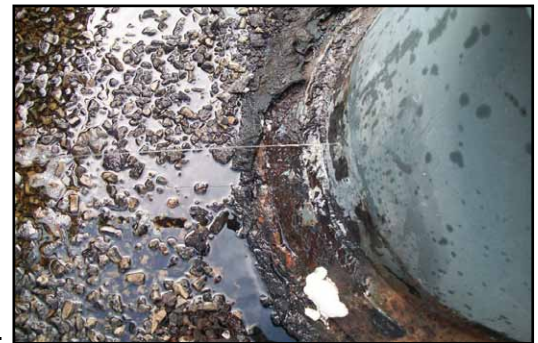
2.

Corrosion and oil discharges were observed to the LV Turrets which indicated through wall penetration, placing the asset at high risk of internal contamination. Upon removing bituminous membrane, exposed metal corrosion and active oil discharges from Turret were identified.

Application was carried out in accordance with Belzona Know-How System Leaflets FBC-6, TCC-1 & RPA-1. After isolating the oil conservator tank and marking area of repair to each Turret, the bituminous coating to the base was removed. Substrate degreased and prepared by MBX and hand abrasion. All live leaks were stemmed using Belzona 1291. Doubler plate covering the Turret circumference/base bonded in place with Belzona 1161. Once cured, Belzona 5831 applied to provide corrosion protection and finally Belzona 3121 applied to seal full circumference of Turret to roof joint.
