## BELZONA IDEAL SOLUTION FOR DAMAGED CONVEYOR BELT

Paper Mill, São Paulo, Brazil

September 2011

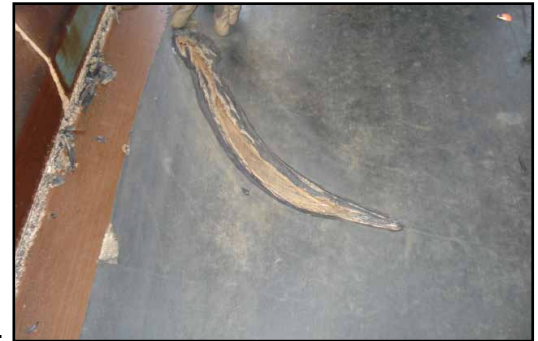
The fork lift driver caught the conveyor belt while he was loading the paper, stopping the process and tearing the belt.

1. Conveyor belt damage
2. Preparation and conditioning with Belzona® 2911
3. Belzona® 2311 being applied and incorporating Belzona® 9341 (Reinforcement Tape)
4. Job done
