BELZONA SEALS ROOF OVER PRODUCTION AREA

Extraction outlets on roof over production area.

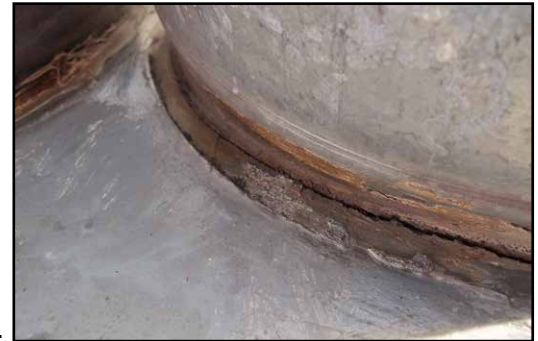
The effect of weather and UV caused rubber seals around ductwork penetrations to degrade allowing rainwater to leak directly into the production area creating disruption in production and safety issues.

1. Deteriorated joint
2. Belzona® 2211 applied to seal gap
3. All joints sealed with Belzona Elastomer
4. Fully Reinforced Belzona® 3111 system applied to give additional sealing and protection
