EMERGENCY REPAIR OF TYRE AT QUARRY WITH BELZONA

Tyre on heavy loader operating in quarry

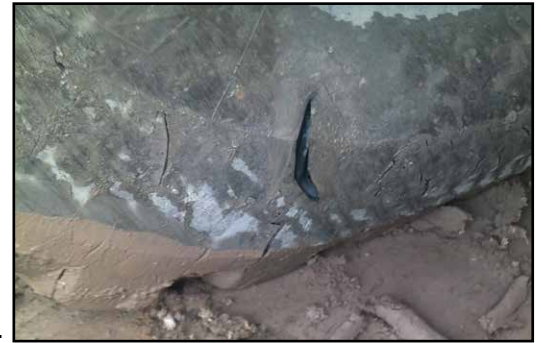
The tyre on the loader was damaged by sharp edged rock. Air was leaking when the crack was in bottom position under full load. Customer needed emergency repair so the loader could continue to operate until new tyres could be purchased and installed.

1. Damage in tyre 2
2. Damaged area prepared and conditioned with Belzona® 2911
3. Embedding Belzona® 9341 (Reinforcement Tape) into the crack
4. Repaired tyre ready to operate
