BELZONA PROTECTS HOT PIPEWORK

Refinery, Germany

Hot pipework (aprox. 110°C) in the refinery

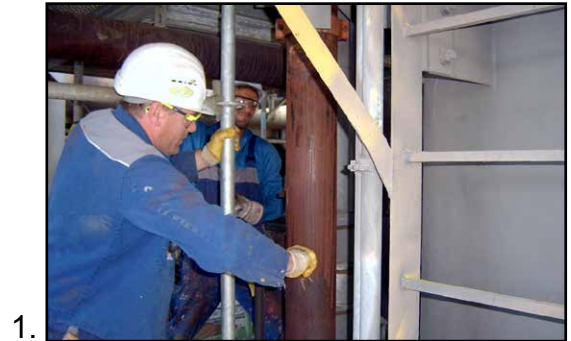
1. Surface preparation underway
2. Temperature reading of the hot pipe
3. Application of coating
4. Finished application

Application was carried out in accordance with Belzona System Leaflet TCC-5. As the pipe was in hot service only minimal surface preparation could be carried out to remove the existing coating. Once the pipe was returned to a sound substrate, the product was applied by brush to the hot pipework.
