BELZONA SAVES CRITICAL EQUIPMENT AT ZINC MINE

Zinc Mine, Namibia

Raw ore mill at a zinc mine and refining facility

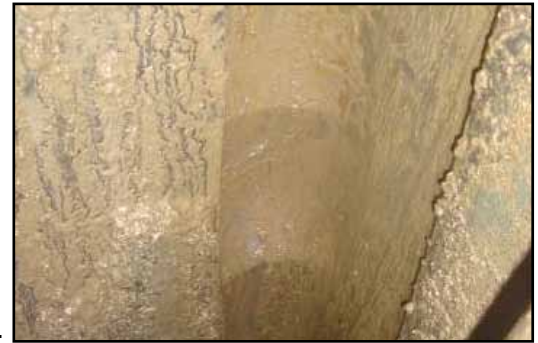
Wear on the riding ring of the primary ore mill resulted in the development of a hole. This allowed leakage of slurry into the mill gearbox lubrication system. As this was a single stream mill, this was a critical piece of equipment and needed to be returned to service immediately.

1. Aerial view of the Zinc mine
2. Initial view of the damaged area
3. Damaged area following cleaning
4. Belzona 1111 repair 3 years later

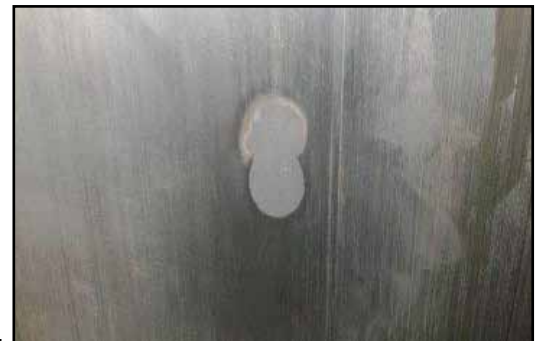
4.

Belzona 1111 quickly sealed the leaking areas, preventing further contamination and allowed the critical part to return to service faster than conventional repair techniques, saving the customer in downtime and resulting production losses. After three years the repaired area was inspected and is still in perfect condition.

Belzona 1111 Super Metal was applied in accordance with a modified version of Belzona Know-How System Leaflet TCC-5
