BELZONA SEALS LEAKING CABLE END BUSHING

Electricity substation, UK

MAY 2013

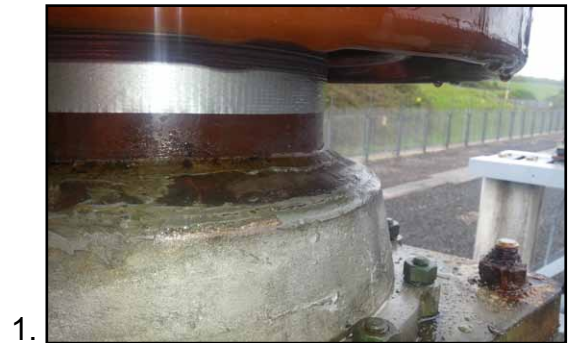
Cement joint between porcelain and steel flange had broken down on bushing - Yellow Phase

1. Transformer bushings
2. Ceramic insulator after abrading with Dremel and cleaning
3. Ceramic insulator and bushing masked off
4. Application completed
