CORRODED FLANGE GROOVES REFORMED WITH BELZONA

Hydropower plant, Switzerland

February 2012

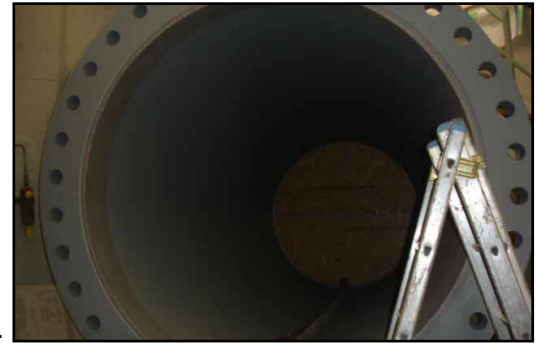
Flange grooves in four pipe flanges. Each flange had a diameter of 1820mm; the grooves were 16mm wide and 3-4mm deep.

Corrosion leading to incorrect sealing of mating surfaces

1. General view of the equipment before application
2. A pre-cut template allows for simple, effective defining
3. Belzona 1321 applied for a smoother surface
4. Pressure pipe after re-assembly

Application was carried out in accordance with Belzona System Leaflet VPF-1. After grit blasting, Belzona 1111 was packed densely into the groove and, using a simple pre-cut template, the original profile was recreated. Finally, a thin layer of Belzona 1321 was applied to create a smoother surface.
