BELZONA RESTORES WORN ARCHIMEDES SCREW

Wastewater Treatment Plant, Ohio

58' long Archimedes Screw used to lift water at the water treatment plant.

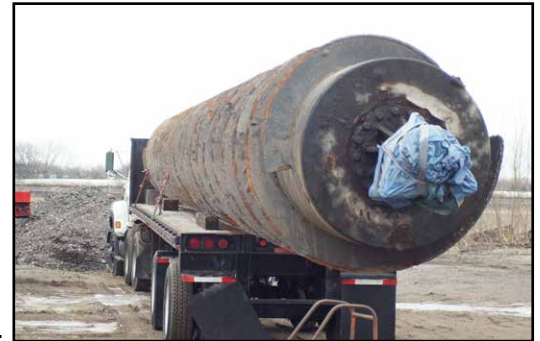
1. 58' Archimedes Screw on Flatbed Hauler
2. Worn Flights on Archimedes Screw
3. Blasted and prepared for application
4. Belzona® 1812 applied to the Flights

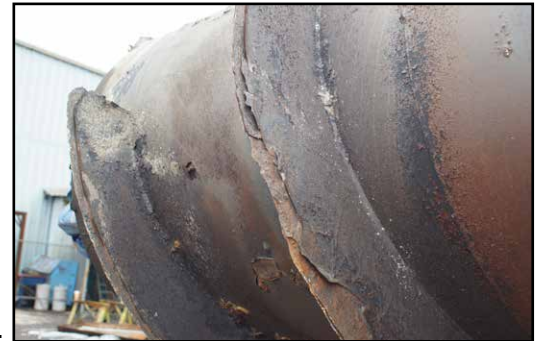
2.

Erosion and corrosion caused the edges of the screw flights to be worn down, thus losing efficiency.

Application was carried out in accordance with Belzona Know-How System Leaflet SHM-14. The entire 58' long screw was blasted before applying Belzona® 1811 to rebuild and reinforce the edges that were worn down. Where large sections of the flights were missing, expanded metal was welded in place prior to applying the Belzona® 1811.
