BELZONA REPAIRS AND PROTECTS QUENCH TOWER

Petro Chemical Complex, Western India

Quench tower suffering Corrosion Under Insulation (CUI).

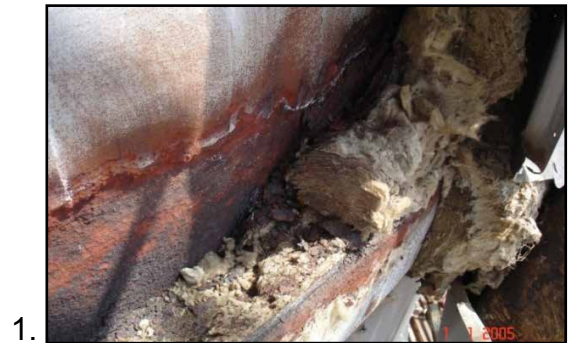
The tall carbon steel tower contains many trays and is insulated to prevent heat loss. Water penetration and condensation had led to severe CUI in many localised areas. The thickness of tower walls had reduced by more than 50% in some areas.

1. Surface condition behind insulation at 7m height
2. Severe damage due to CUI
3. Application of Belzona® 1251
4. Completed rebuild with high temperature barrier coating Belzona® 5851 applied to prevent further corrosion
