## BELZONA PROTECTS AMINE REBOILER

Gas terminal, UK

Amine reboiler vessel

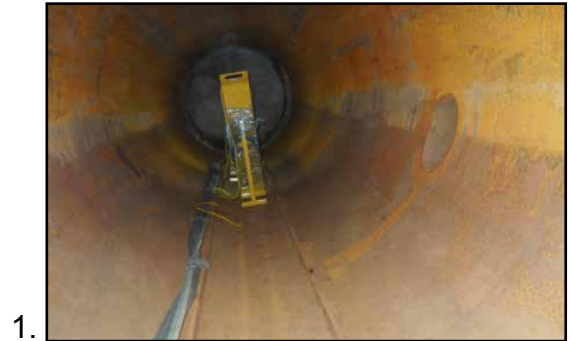
Internal corrosion with heavy pitting in areas.

1. Interior of vessel before blasting
2. Large areas of pitting
3. Vessel before application of first coat Belzona® 1591
4. Coated vessel before final remedial work carried out

Application was carried out in accordance with Belzona Know-How System Leaflet TCC-5. Belzona® 1511 was used to fill in pitting. Belzona 1591 applied for overall corrosion protection.
