BELZONA PROTECTS FLARE DRUM

Refinery, UK

Flare knock-out drum

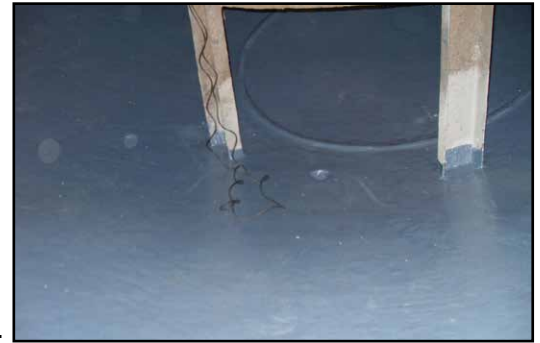
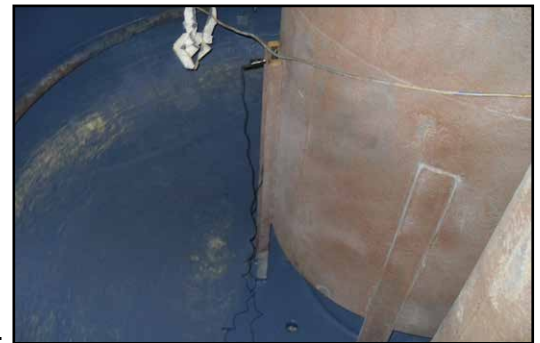
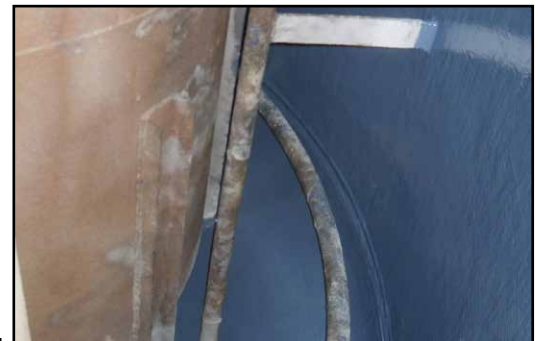
1. 2 & 3. Various views of the Belzona® 1391 applied to the vessel interior.

Vessel suffering internal corrosion. Coating required to extend service life of the vessel.

Application was carried out in accordance with Belzona Know-How System Leaflet TCC-5.
