BELZONA CONTAINS 98% SULPHURIC ACID ACID

Chemical Plant, Porto Feliz, Brazil

Loading bay for 98% Sulphuric acid.

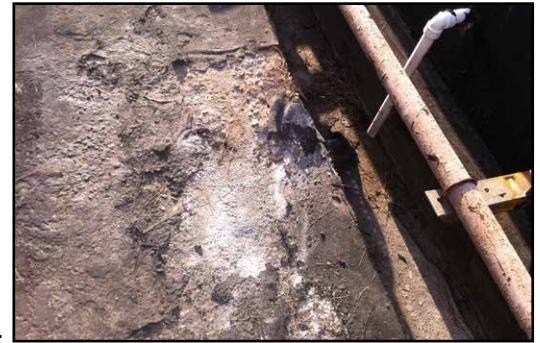
Previously used coatings had failed allowing the acid to attack the underlying concrete.

1. Failure of previously used coating
2. Surface prepared
3. Substrate conditioned with Belzona® 4911
4. Finished job

Application was carried out in accordance with Belzona Know-How System Leaflet TCC-15. Old coating was removed and damaged concrete rebuilt with new concrete. After drying out for 28 days 2 coat system of Belzona® 4311 was applied.
