BELZONA QUICKLY RESTORES & UPGRADES TURBINE PROTECTION

Hydropower plant, France

A Francis turbine runner which had been previously coated 15 years ago.

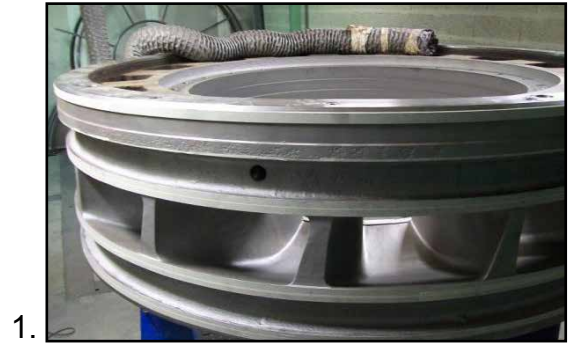
1. Blasted runner prior to the application
2. Mixing of Belzona® 2141
3. Application of Belzona® 2141
4. Completed equipment

Application was carried out in accordance with Belzona Know-How System Leaflet CEP-3. The bottom and top parts only needed a protection against corrosion and not erosion: Belzona® 5811 was used. The middle part had a serious problem of cavitation: Belzona® 1341 and Belzona® 2141 were used.
