BELZONA REPAIR TO LOADER TYRE SIDEWALL

Quarry in Croatia

April, 2013.

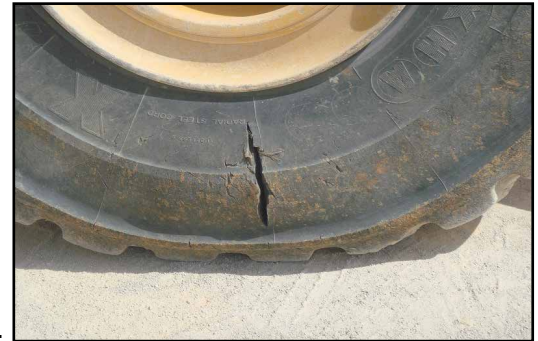
There was a large crack in a tyre, but it was not leaking and the steel reinforcement was still in good shape. Customer needed to keep the loader in operation.

1. Damaged tyre on wheel loader
2. Application in progress
3. Application finished
4. Site revisited after 3 months, the tyre is still in perfect shape

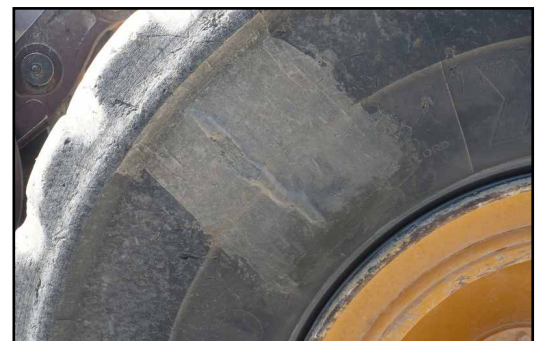
The two alternatives were either to replace the tyre or to dismantle it and transport it to the nearest workshop. Belzona repair was carried out during the weekend and customer didn't lose any production time. The Belzona repair prevented further deterioration of the tyre and was performing well when expected three months later.
