## CORROSION PROTECTION OF DISTRICT HEATING PIPEWORK WITH BELZONA

District heating company, Sweden

District heating system. Pipework in access chamber.

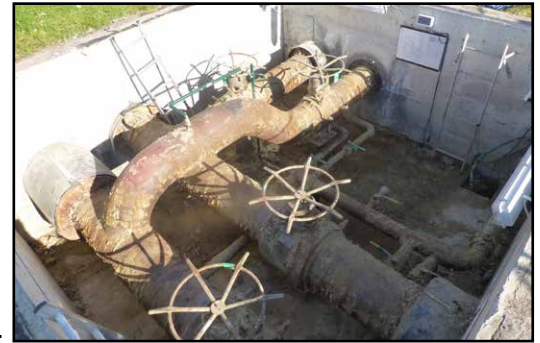
Corrosion under insulation and on the pipes, valves and other naked steel parts, due to water penetrating into the chamber.

1. General view of corroded pipework in the access chamber
2. Blasting, with dry ice
3. Coating the hot feedpipe with Belzona® 5851
4. Completed work, with Belzona on all exposed steel parts
