BELZONA REPAIRS DAMAGED PORCELAIN SHED

Power Distribution Company Substation, UK

September 2013

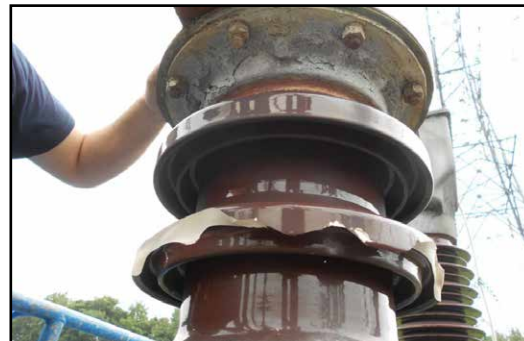
Porcelain shed damaged by contact with mechanical platform access lift during outage procedure.

1. Damaged porcelain shed
2. Elastomer former mould
3. Elastomer former with Belzona 8112 attached to shed
4. Completed repair with innovative rainfall protection
