BELZONA REPAIRS A TIRE OF A DUMP TRUCK

Mine, MG, Brazil

Tire of a dump truck

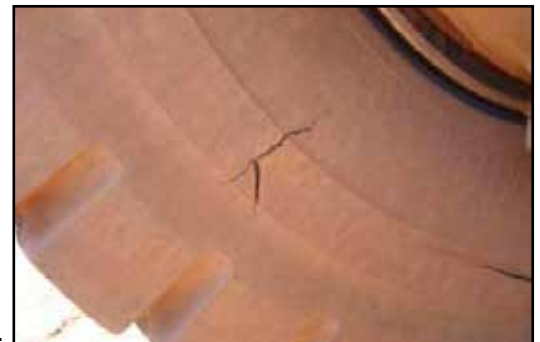
One of the tires of the dump truck had two lateral cuts, which reached the metal mesh and may have been caused by stone impact during movement. It was necessary to repair the affected area in order to prevent the cut from expanding and the tire to become useless before the end of its useful life. Lateral cuts measured 130 mm and 500 mm in length and 40 and 60 mm in depth.

1. One of the cuts on the side of the tire
2. Another cut on the side of the tire
3. Application of Belzona 2311
4. Application of Belzona 2211

The application was conducted according to Belzona Know-How System Leaflet SHM-9. The lateral cut was opened and all the loose rubber was removed, reaching the inner liners, without exacerbating the problem. After scarification of the rubber, cleaning of the cut and application of Belzona 2911 conditioner, two repairs were made: the first one with the application of Belzona 2311 and the second one with the application of Belzona 2211.
