BELZONA REPAIRS CABLE REINFORCED CONVEYOR BELT

APPLICATION SITUATION
Cracked cable stayed belt

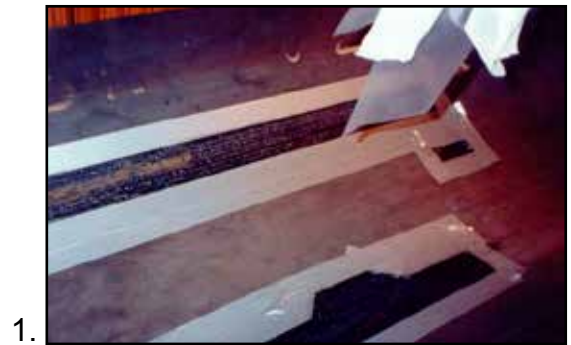
1. View of preparation in progress
2. Close-up of one of the repair areas
3. Completed application.
