EXPANSION JOINTS REPLACED AT WASTEWATER PLANT

Primary Wastewater clarifier.

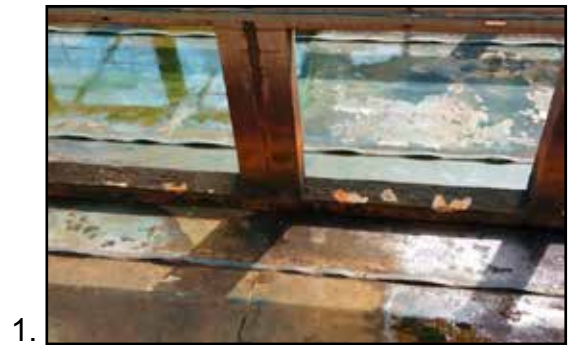
Existing joint material had become defective allowing leaking of fluid.

1. Prior to application
2. Preparation
3. Application
4. Completed application
