## BELZONA SHM-12 POSITIVE GRIP SYSTEMS USED TO RE-LAG DRIVE PULLEY

Rubber lagging on drive pulley

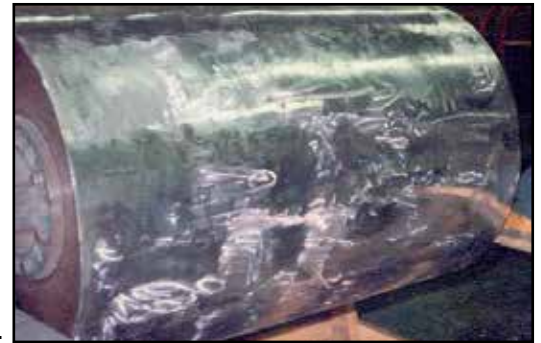
1. The original lagging has been removed and the steel surface ground to provide a rough profile onto which the Belzona product is applied
2. Completed application. In this instance a chevron type pattern was employed to ensure that rain water (Outside application) would be swept to the outer circumferences of the roll.
