BELZONA RESTORES FLOTATION UNIT AT BIOMASS PLANT

Dissolved Air Flotation (DAF) Unit in Biomass Plant

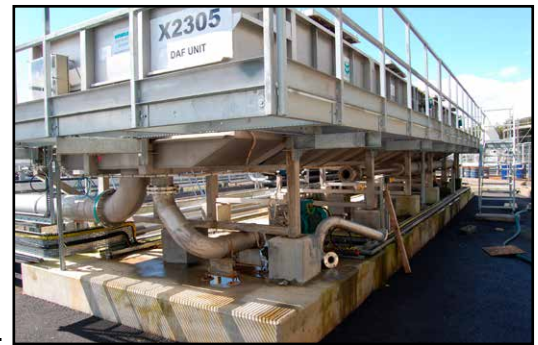
1. DAF unit
2. Pitting Corrosion
3. Rebuilding Application
4. Completed Application

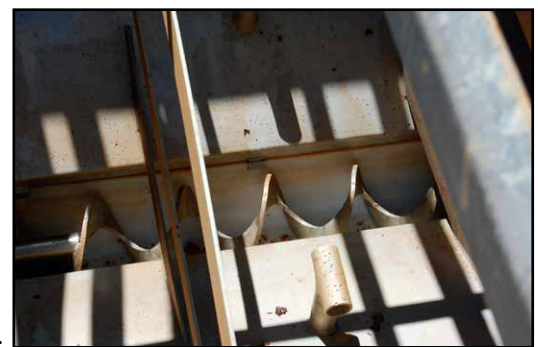
2.

Severe pitting corrosion to the stainless steel unit caused by Ferric Chloride.

The application was carried out in accordance with TCC-1 and TCC-3. Belzona 1111 was used to rebuild the pitting damage. In deeply pitted areas doubler plates were bonded into place. Afterwards the full tank was lined with Belzona 5892.
