BELZONA ELASTOMERS REPAIR CUT IN TIRE

APPLICATION SITUATION
Damaged tire

PROBLEM
Tire on earthmoving equipment had been badly damaged.

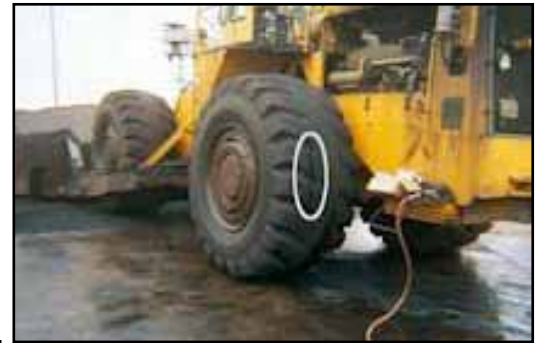
1. View of equipment and the extent of the damaged area
2. Surface around the damaged area prepared and coated with Belzona 2911
3. Damaged area sealed and rebuilt with Belzona 2211
