BELZONA REPAIRS AND SEALS CRACKED TRANSMISSION CASING

PROBLEM
Repairing cracked and leaking transmission housing

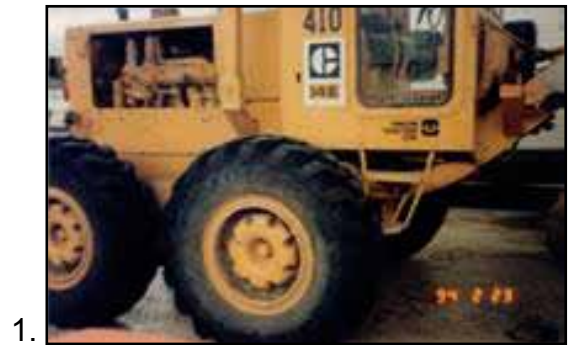
1. View of equipment
2. Crack "v" out and the surface area around it roughened
3. Belzona 1111 applied to the area around the repair
4. A reinforcement plate bolted over the uncured Belzona material to provide additional mechanical strength to the area.
