BELZONA 2311 (SR ELASTOMER) USED FOR EMERGENCY REPAIRS

APPLICATION SITUATION
Belt repair in gravel pit

PROBLEM
A small cut had developed in a section of the belt

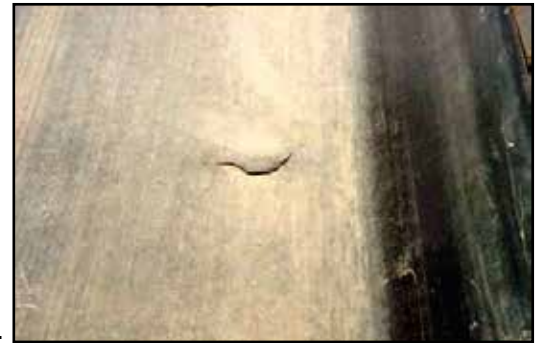
1. View of the cut in the belt
2. Initial preparation underway
3. The loose piece of belting has been cut away and area around it roughed up with a special roughing tool
4. Repair in progress
