## BELZONA 2200 SERIES ELASTOMERS REPAIR SPLIT CONVEYOR BELT

Split belt repair

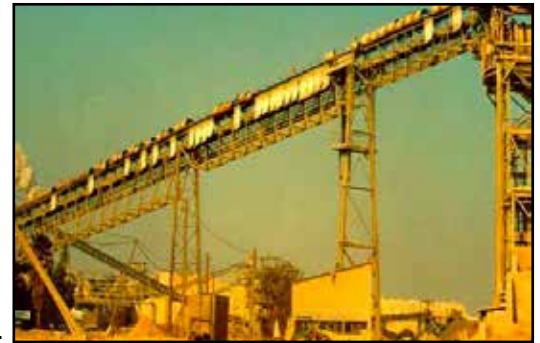
A mechanical breakdown had caused the belt to be split over a length of approximately 100 feet.

1. Conveyor system in need of repair
2. The damaged portions of the belt were held together using mechanical fasteners
3. Close-up of fasteners and the prepared belt surfaces conditioned with Belzona 2911
4. The completed repair
