BELZONA REBUILDS ERODED METAL AND DAMAGED LINER

APPLICATION SITUATION
Lining repair of a sand and gravel hopper

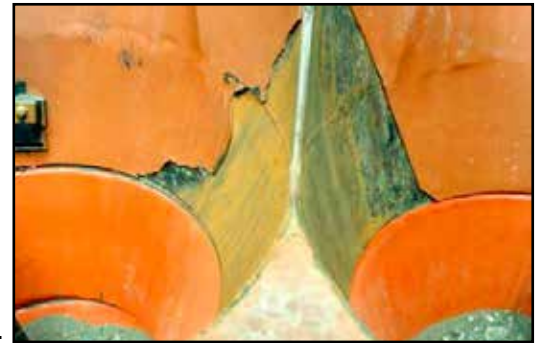
1. Sand and Gravel Hopper
2. View of the damaged liner
3. Damaged liner stripped from the affected areas
4. After preparing the metal surfaces the eroded area was rebuilt with Belzona 1311

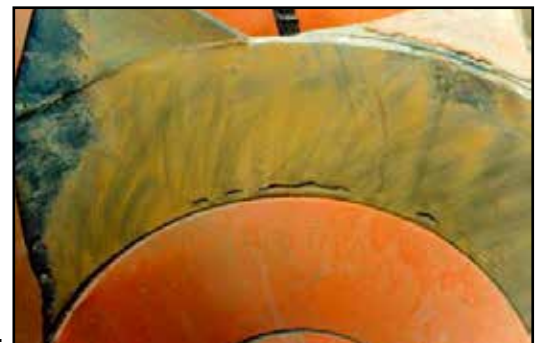
PROBLEM
The abrasion resistant lining of the hoppers had been damaged allowing corrosion to develop underneath it
