## BELZONA 1111 SUPER METAL SOLVES PROBLEM QUICKLY

**APPLICATION SITUATION**  
Cracked hopper

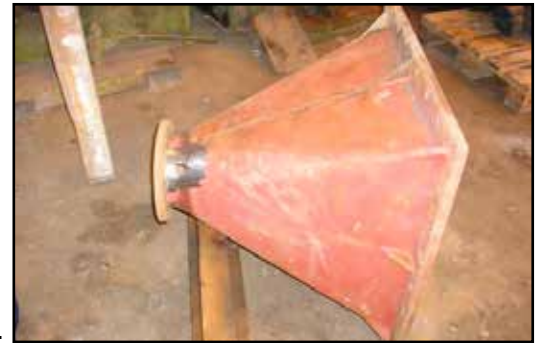
**PROBLEM**  
Due to the continuous flow of abrasive aggregate and vibration the transition piece would wear out and crack.

1. The area to be repaired was ground to a clean rough surface with a mechanical grinder
2. Repair in progress
3. Completed repair.

**BELZONA FACTS**  
The use of Belzona to bond a patch over this problematical section proved to be quicker and easier to do than welding. The repair also lasted well beyond the standard welded repair.
