BELZONA EXTENDS LIFE OF JET VALVE

Worn jet valves

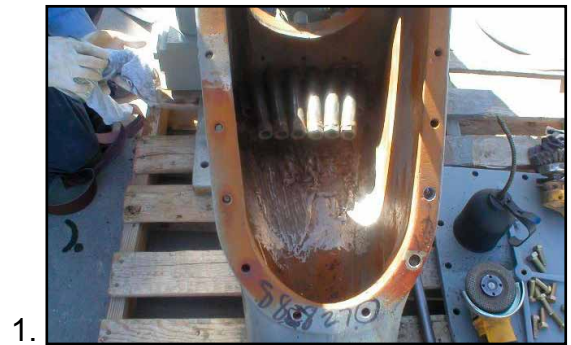
1. View of the volute area
2. Showing preparation in progress of the eroded area
3. Application of the Belzona material in progress
4. Application of the Belzona 1812 in progress
