## BELZONA CREATES IRREGULAR SHIM FOR DRAGLINE ROTATING BLOCK

Worn rotating block base

The base of the rotating block had worn unevenly creating an uneven mounting surface.

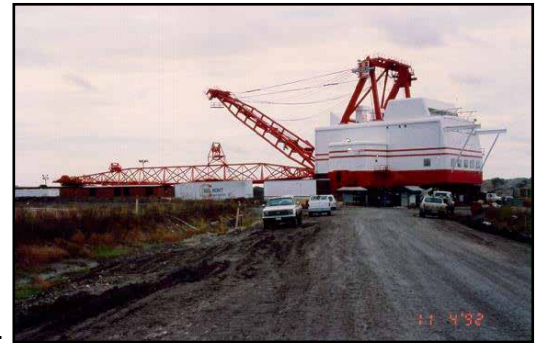
1. View of Dragline Equipment
2. Injection ports in place
3. Injection gun filled with Belzona 1341
4. Injection in progress
