BELZONA REPAIRS AND COATS PUMP CASE

Mine, Brazil

May 2006

Pump case.

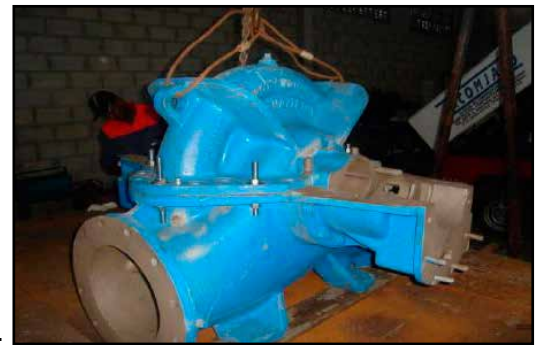
The equipment presented minor wear due to localized corrosion on the casing. It was necessary to restore the worn areas and apply a lining with excellent corrosion and high temperature resistance. The fluid consists of a caustic soda solution with few solids at a temperature of 81° C. Speed rotation: 1789 rpm.

1. Equipment assembled before the repair
2. Case refurbishment with Belzona 1111
3. Case refurbishment concluded with Belzona 1111
4. Service concluded, case lined with Belzona 1391
