BELZONA REPAIRS DAMAGED WASTEWATER PUMP

Water Authority, N. Ireland

May 2014

Damaged wastewater pump

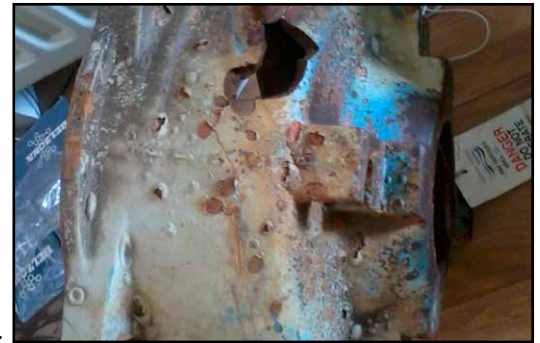
Erosion from solid material in process fluid had destroyed impeller and holed casing of a wastewater pump.

1. Holed pump casing
2. & 3. Pump casing rebuilt with Belzona

Application was carried out in accordance with Belzona System Leaflets CEP-3 and CEP-6.

The customer had previously used welding to repair the damage but sought a longer lasting, durable repair that did not involve hot work. While the Belzona solution avoided the need to use hot work, it also ensured the equipment could be placed back into service in just 2 days.
