BELZONA REPAIRS THE GRIP OF A CONVEYOR PULLEY

Mine, Chile

August 2005

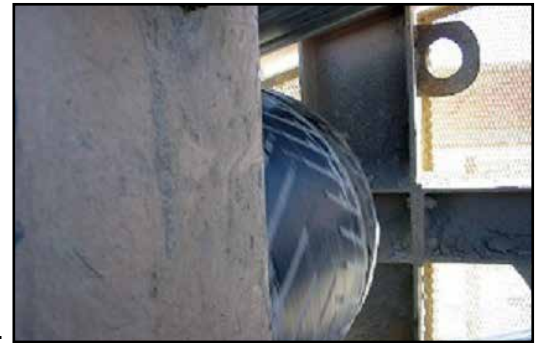
Due to moisture problems, the conveyor belt slipped from the pulley, burning the coating, which led to loss of grip.

1. Damaged pulley
2. Drawings on the pulley, applying Belzona 1321 and Belzona 9211
3. Pulley coated with Belzona 1321 and Belzona 9211
4. Application completed
