BELZONA SEALS A CRUSHER LUBRICATION TANK

Mine, Chile

June 2010

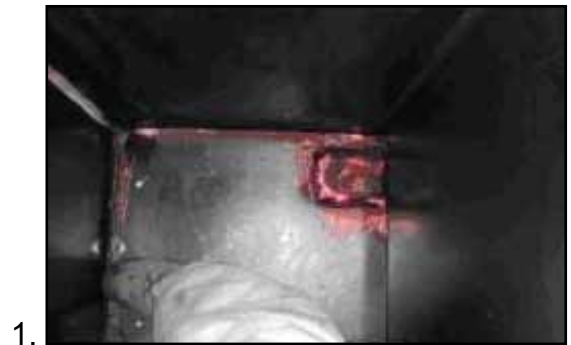
Oil filtration in the welds and joints. Leaks are detected by applying penetrating dye.

1. Original tank conditions where the penetration of the dye can be observed
2. Prepared surface
3. Another view of the prepared surface
4. Completed application
