BELZONA REPAIRS A CRUSHER'S BOWL LINER BASE

Mine, Chile

Repair of the worn-out area and installation of the new crusher's bowl liner.

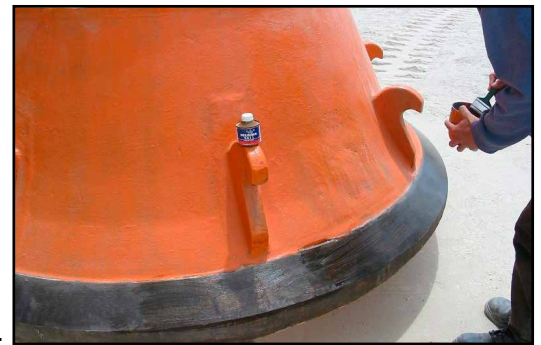
1. Application of Belzona 9411 on the area of the bowl liner
2. Application of Belzona 1111 on the fastener of the base of the bowl liner
3. Application of Belzona 1111
4. Installation of the fastener over the bowl liner

The damaged area on the base of the fastener of the bowl liner was cleaned. Belzona 9411 was applied on the bowl liner, Belzona 1111 was applied at the base of the fastener of bowl liner and the pieces were later joined, before Belzona 1111 could cure to make a mold.
