BELZONA REPAIRS CRUSHER'S ADJUSTMENT RING

Mine, Chile

February 2006

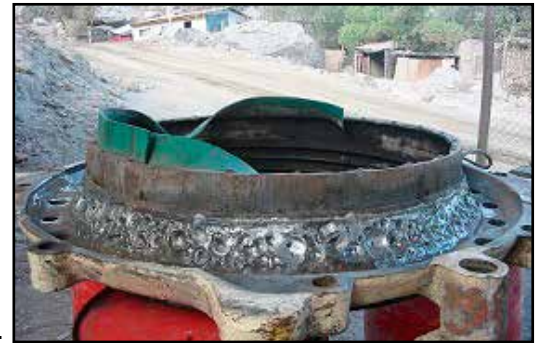
The worn-out strip prevented the crusher from functioning well.

1. Damage on the ring of the crusher
2. Application of Belzona 9411 on the surface of the crusher
3. Application of Belzona 1111 on the strip of the worn-out ring
4. The ring repaired with Belzona 1111
