## BELZONA COATS THE EXTERIOR OF AN ACID PUMP

Mine, Chile

October 2006

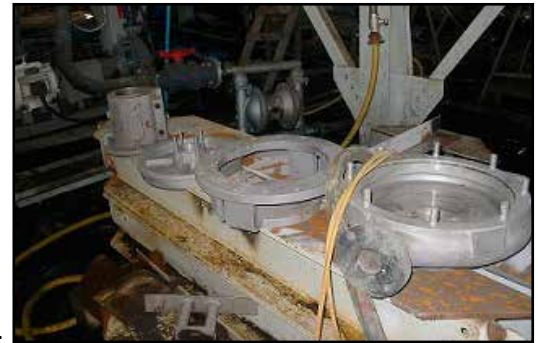
1. First blasting of the pump
2. Second blasting, ready to apply the coating
3. Application of Belzona 4311
4. Pump coated with Belzona 4311

The pump was blasted to white metal to eliminate the acid contained in the substrate. Then, two coats of Belzona 4311 were applied to the external part of the pump.
